# ASSET CONDITION ASSESSMENT

## AstraPool E-Series 230 Pool Pump

Baseline non-invasive inspection • 7 August 2026

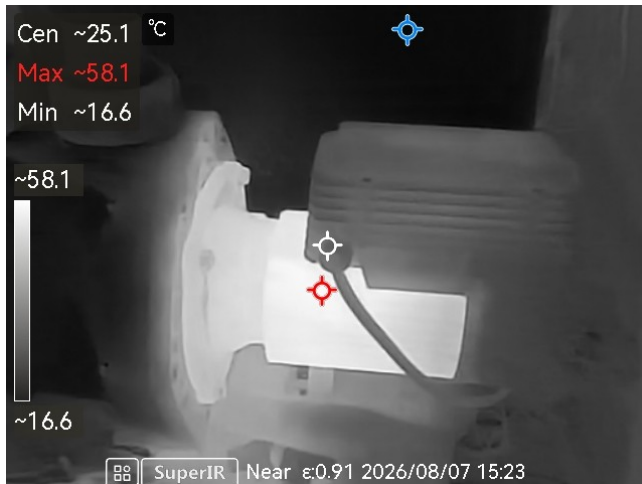
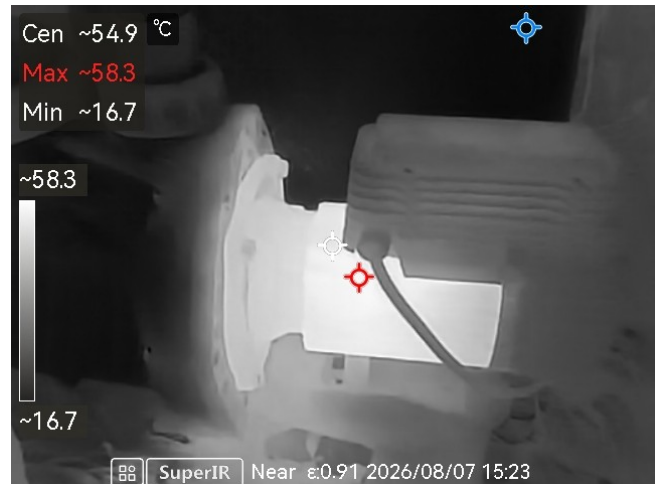
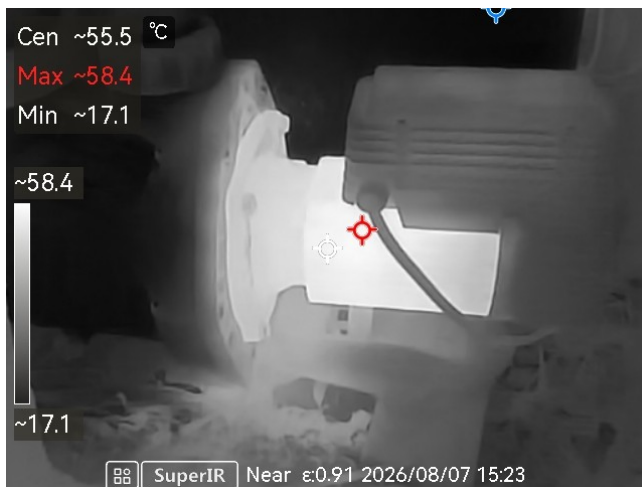
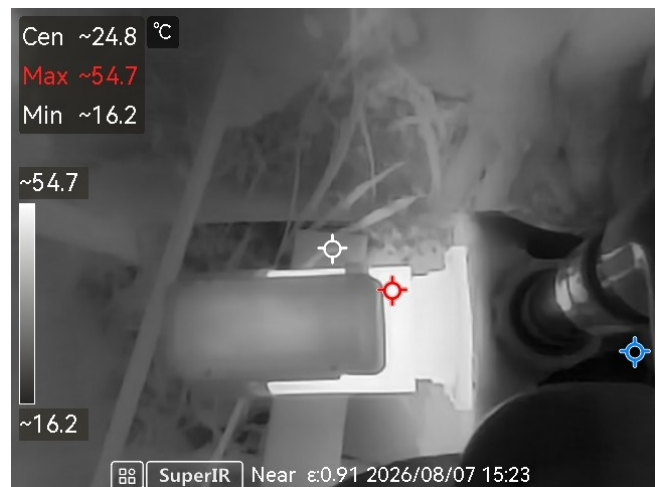
Thermal images were captured after approximately two hours of operation. The supplied images show maximum indicated temperatures of approximately 58.1 °C, 58.3 °C and 58.4 °C across similar views, with an opposite-end view showing

approximately 54.7 °C. The externally visible assembly displays a broadly consistent thermal pattern with no obvious isolated hot spot in the captured views. Camera emissivity shown in the images was  $\epsilon = 0.91$ .

- Record water flow rate under normal operating conditions.
- Record filter/system pressure under the same operating condition.
- Establish operating current where it can be measured safely and within authorised scope.
- Establish quantitative vibration measurements and spectra at repeatable motor/bearing locations.
- Define repeatable thermal measurement points and record ambient, reflected apparent temperature, humidity, distance, viewing angle and operating state.
- Retain a repeatable 20-30 second audio recording as a qualitative comparison reference.
